CSIRO BELMONT UPDATE

NOVEMBER 2019

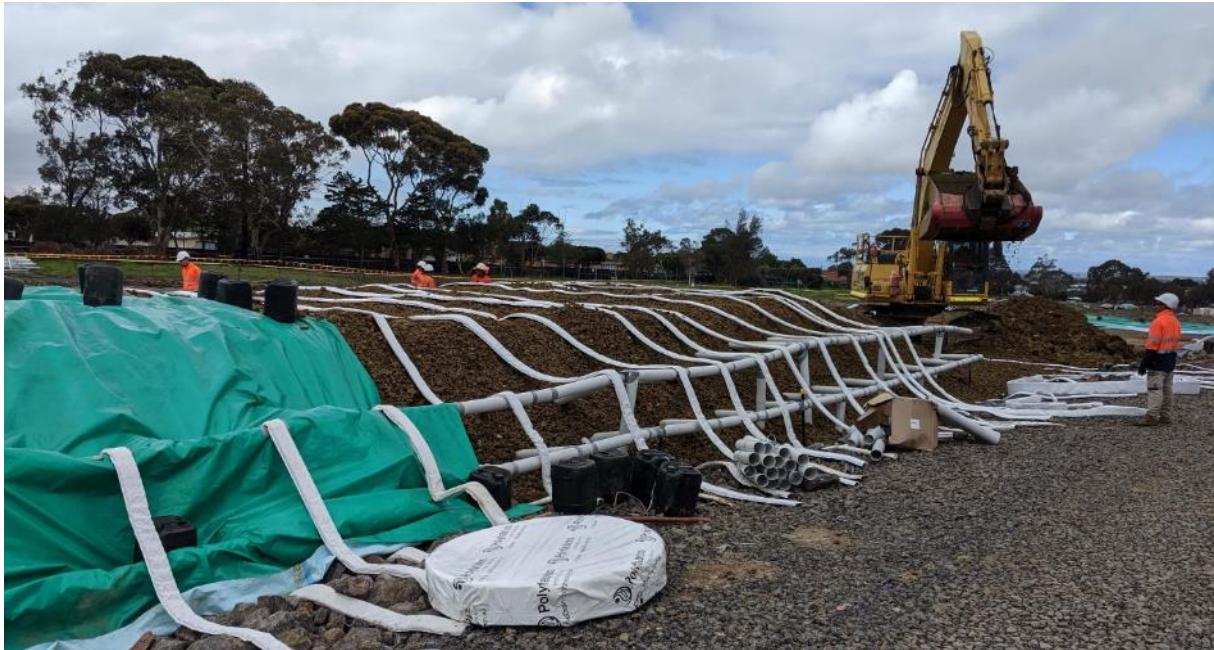
Formation of stockpiles with ventilation

Once the clay is broken-up in the tent, it is being transported by a “moxy” truck and stockpiled along the southern side of site. These stockpiles have filtration material running through the soil. The flexible filtration material is connected to manifolded pipes, extracting and filtering the hydrocarbons from the soil. This extraction process will prevent nuisance odours.

EPS estimate the stockpile construction process to be completed by the end of November 2019 subject to weather and volume of material. The stockpiles will be placed running east to west approximately 20 m away from the south boundary and they will be approximately 2m high and 300m long. At the completion of the stockpiling, the tent will be deconstructed and removed from site.

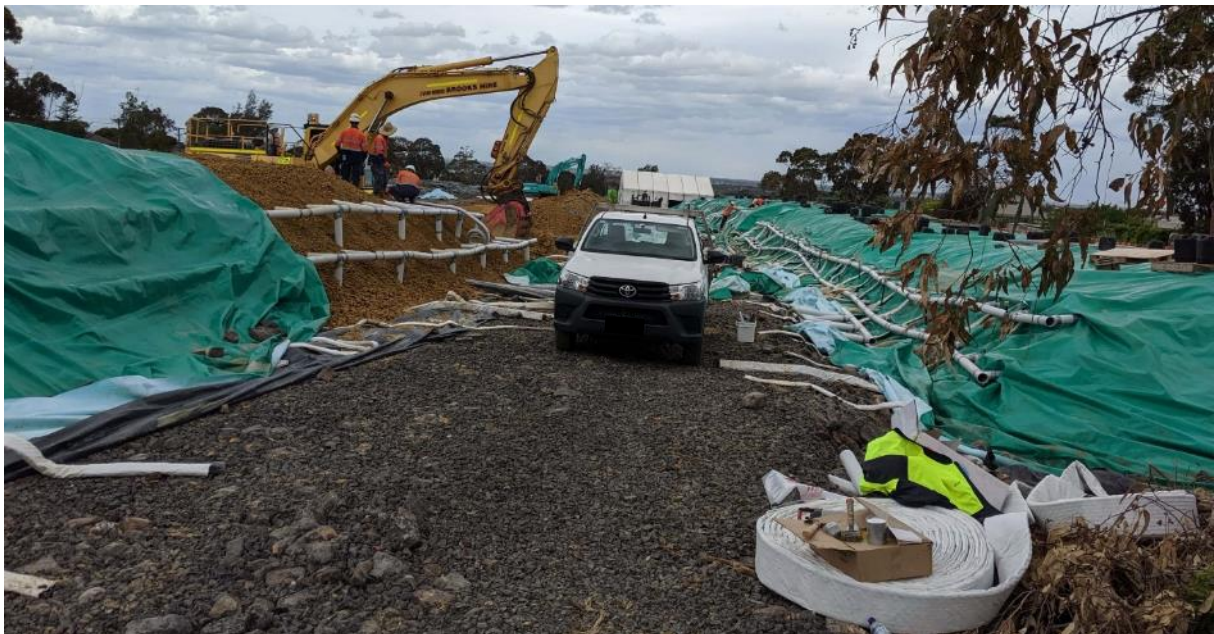
Progress with SVE stockpiles

Extraction and filtering of the stockpiled materials to remove hydrocarbons from the soil will take place over approximately 16 weeks, during which time the environment will be monitored. To minimise disruption to neighbours, the extraction system will be surrounded by noise reduction material, such as hay bales.

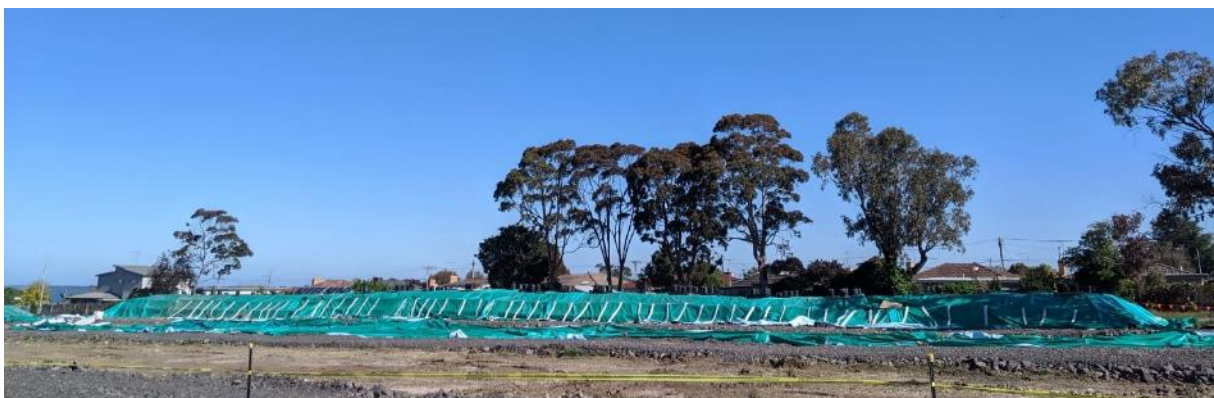
Stockpile covered with plastic and extraction pipes

Stockpiled materials around the site will be covered with tarpaulins to control any water ingress, loss of soil and dust being windblown. When the hydrocarbon level has been reduced to a satisfactory level, the material will be replaced into the excavation hole and compacted. The project team anticipates that the works to be completed by the end of April 2020.

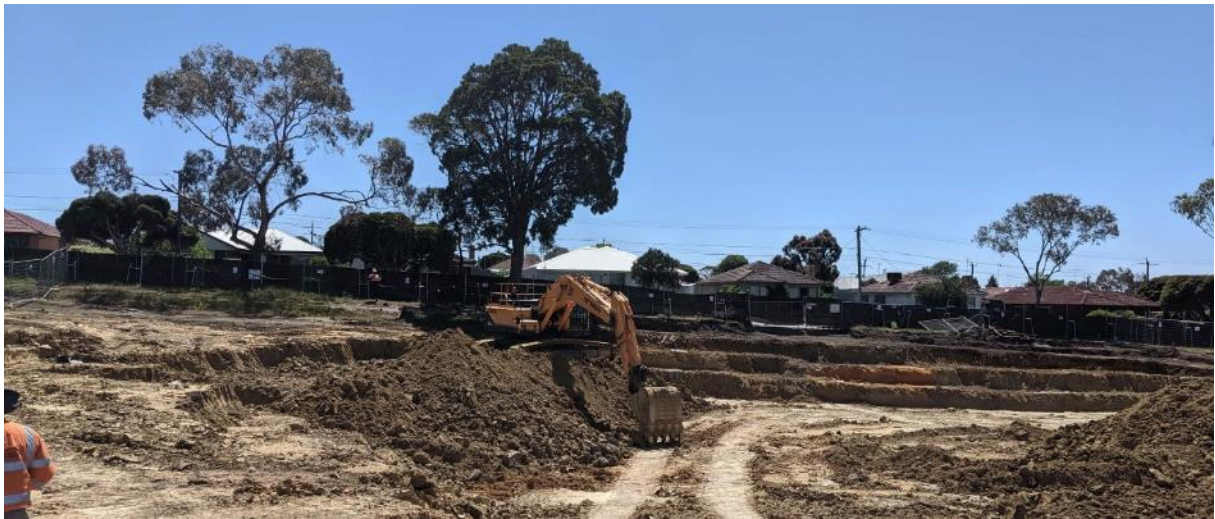
Benching the soil whilst excavating for the soil vapour extraction material to keep the pit stable

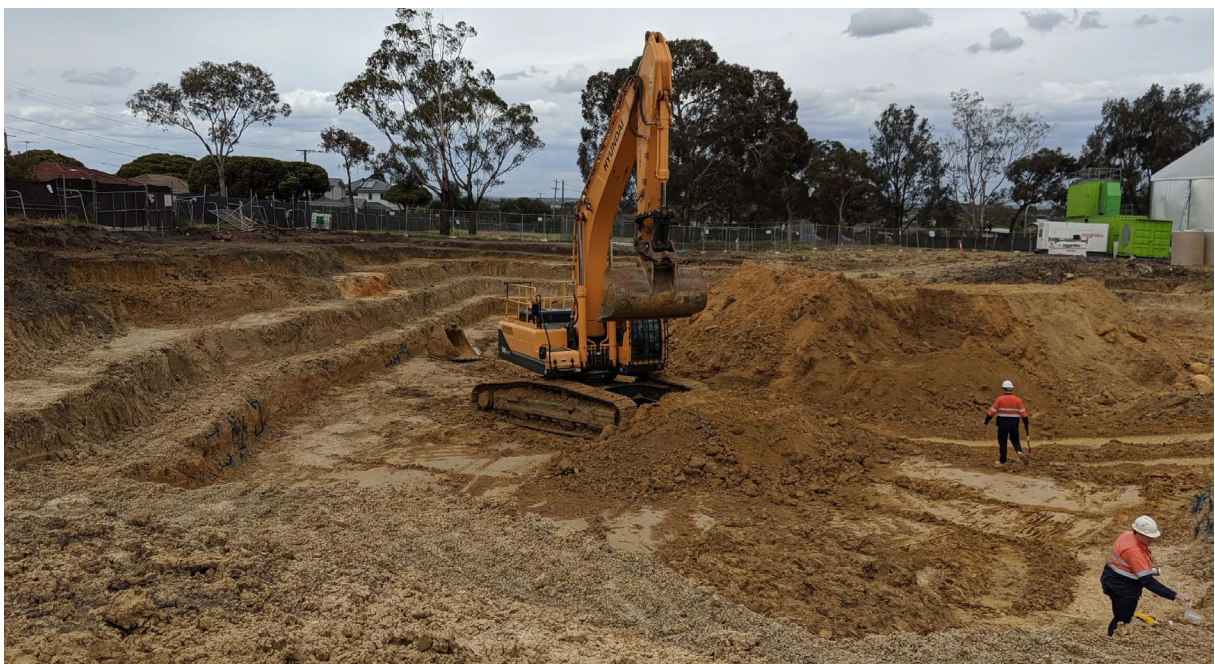
Progress on excavation pit

EPS continue to excavate non-asbestos contaminated soil for remediation from the pit area and are processing this soil in the large white tent to break the clay in to smaller clumps to enable the release of hydrocarbons. During the processing of soils within the tent, there may be occasional mild odours carried by the wind. This nuisance odour is not harmful, and EPS is attempting to control this odour at the boundary so that it is below what can be smelt by a normal person (the so-called odour threshold).

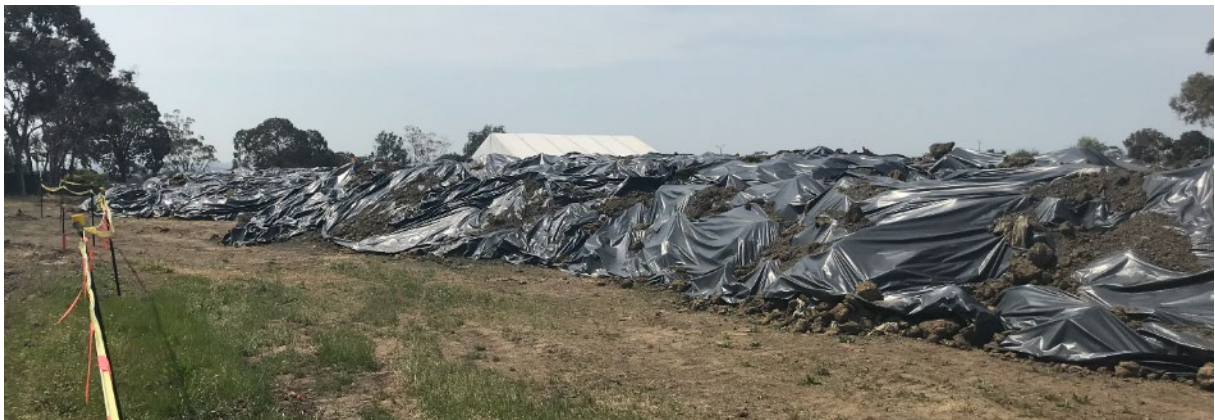
Asbestos contaminated soil stockpile, covered with heavy black plastic (weighted down with clean soil) to prevent dust and water ingress.

Our contractors, Enviropacific Services (EPS), have again separated asbestos contaminated soils from clean areas within their work site. The asbestos contaminated soil has been stockpiled and covered to prevent dust and water ingress. This material will be removed from site and transported to an appropriately licenced waste centre, using the same methodology as previously utilised on site. The transporting of the material from site will commence on 2nd December 2019. We expect 30-40 trucks entering and leaving site per day over a period of 10 days to complete the removal of the current asbestos contaminated soil stockpiles.
